Project Reference: 202137

Civil, Structural & Geotechnical Engineering Consultants

3.0 Observations and Assessments

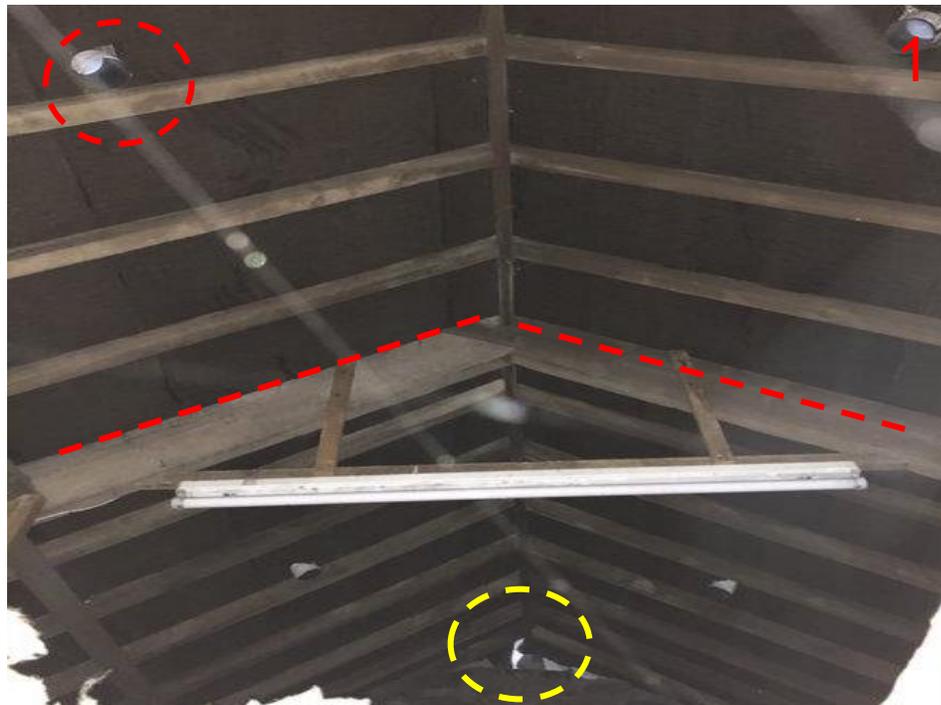
- The roof is constructed with 1No primary 'A' frame rafter measuring 215x75 running front-to-back midspan the building, with a lowered collar running at ceiling level. There is 1 set of purlins running left-to-right on both the front and rear roof elevations. These purlins measure 120x75. See picture 1 below.
- There are roof vents on both roof sides circled in **Picture One**.

- The ridge board measures 150mm x 18mm.
- Roofing felt is present beneath the timber roof batten, the lining is in good order with no visible rips or tares, however daylight can be seen at the join with the neighbouring property as indicated by the yellow circle in picture 1. In this area the chimney stack has been removed and the roof lining replaced with similar tiles and 2No chimney flues.
- There is a minimum of 100mm insulation present in the attic.
- Plastic goods i.e. downpipes and guttering are in good condition throughout.
- The roof lining is finished at the gable end with a dry verge with no overhang present and the fascia board is flush with the gable wall.

- The uppermost structure on the original building is structurally sound, however it is advisable that an inspection of the roof is undertaken to check the daylight that is noticeable in picture 1.

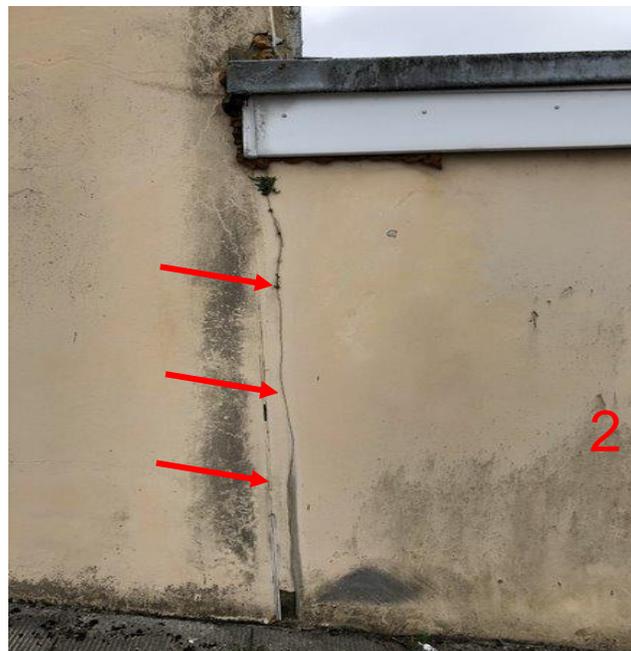
- External walls to the original building are 500mm thick random stone walls with brick inlay on the outer skin around masonry openings. The rear flat roof extension is constructed with a block cavity wall. It is unclear if there is cavity wall insulation.
- The outside and inside have been finished in cement render.
- The internal walls are mostly constructed from modern timber-frame with 12.5mm plasterboard finish which indicates there has been some form of alterations/replacement of the layout of the original internal structure.
- There is a 3-5mm vertical crack at the junction of the original building and the flat roof rear extension, see picture 2 below.

- The vertical crack in picture 2 is highly likely due to differential settlement. Differential settlement is due to movement of the substructure caused by different foundation depths and loadings. This creates a difference in the rate of structural movement or settlement, producing stresses that lead to cracks. Differential movement is commonly found where new extensions with deeper foundations abut an old house, or when bay windows and porches were built with shallower footings than the main property. It must also be noted that due to the topography of the site, the extension has probably been built on some form of made ground.

Repair- the crack is to be cleaned out and fill the crack with a non-shrink thixotropic epoxy resin based external filler to stop and further water ingress. Then observe if the crack reappears over time (5 years).

If it reappears then the crack is progressive and masonry stitching is recommended. A method of stitching would be to use helical stainless-steel reinforcement tie (i.e. Helifix™) resin bonded into the cracks of the inner and outer skin and repointed then the render made good, and/or, a reinforcing mesh system secured to the wall and rendered over to make good. The helical system is inserted horizontally every 400mm due to the nature of the cracking and have 600mm bonded length either side of the crack bending it around any corners where necessary. This is to cease any further movement of the superstructure and stitch the masonry.

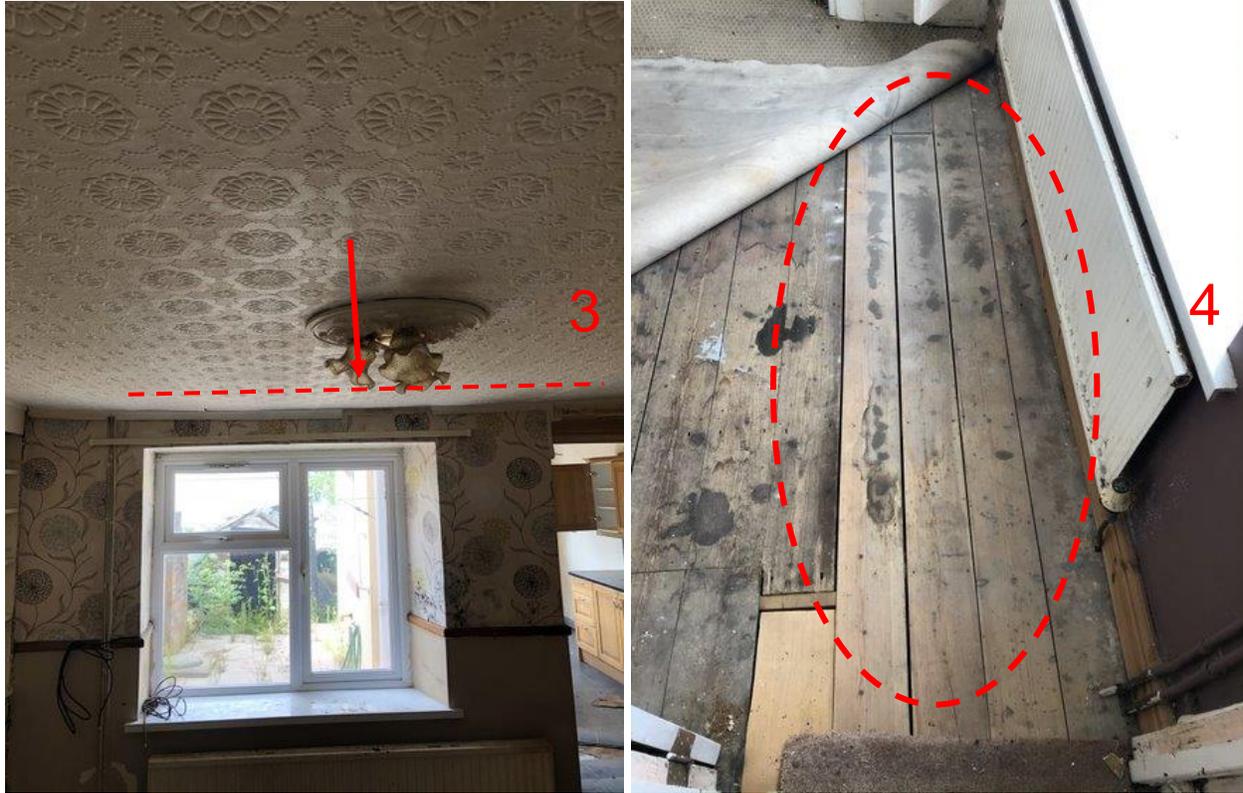
- There are various undulations in the floor throughout the building, including the stairs and landings.
- The floor joist run front-to-back and the ceiling in the rear room of the basement appears to show deflection of the floor joists. However, when the carpet was removed, it was found that the floor joists and floorboards had been replaced in the area over the rear window indicated in picture 3&4.

- The floor joist repair in picture 3&4 appears to have been carried out correctly, however the reason why the ceiling is still bowing is due to either the repair not continuing in the old floor joist pocket, or the ceilings have dropped. It is recommended that the floorboards be removed to fully inspect the repair.
- The damp spores in picture 7 are in the same area as the issues raised in picture 8, therefore it can be assumed that they are linked. A drain inspection is recommended at the LH front corner of the property and the downpipe that is

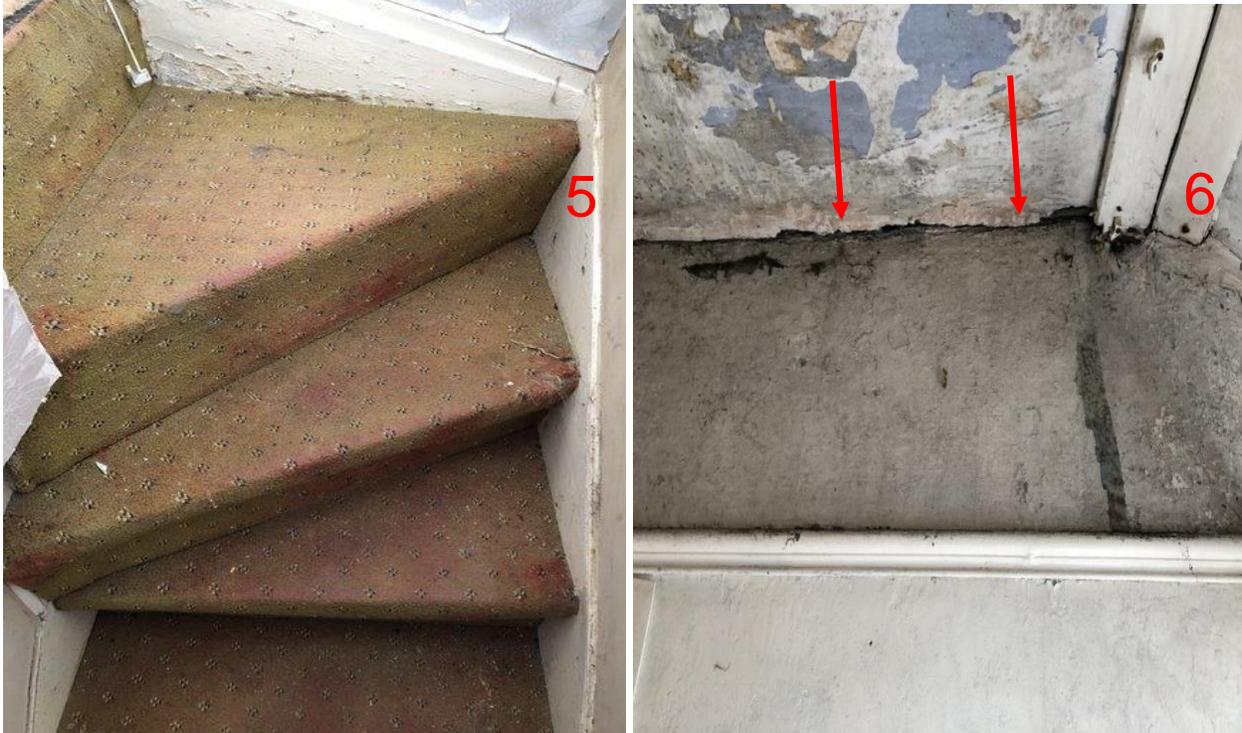
- Both sets of stairs do not conform to modern day building regulations (picture 5), however because the stairs are in situ, they therefore do not need to conform to building regulations. Nevertheless, this is detailed as a Health and Safety issue.

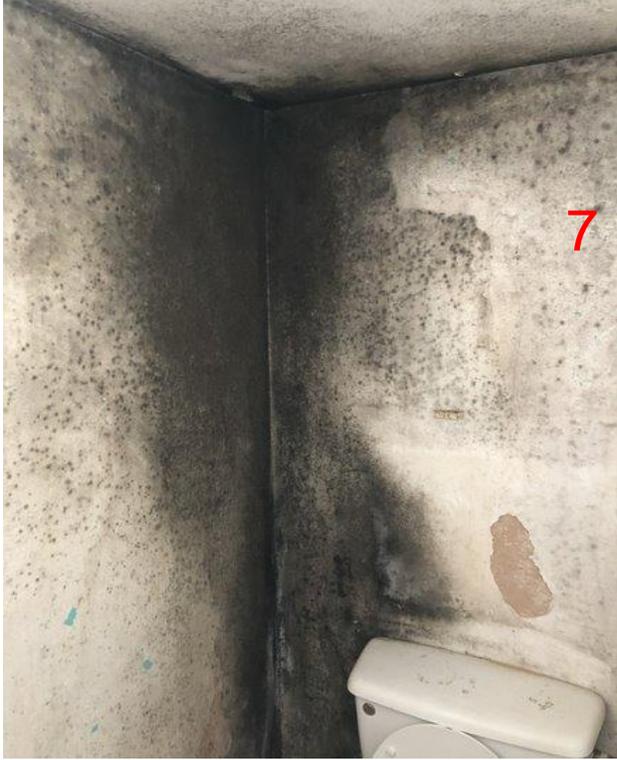
- Picture 6 shows the separation between the ceilings and the gable end on the FF. This is an indicator that the gable end wall has suffered from lateral movement or minor bulging in this area.
 - The wiring throughout the building is outdated and has been clearly modified by an unqualified electrician. Caution must be used when turning on any electrical loop or circuit.
 - Gully pots are partially full of debris. It is recommended to clean out all the drainage areas.
-
- The basement is suffering from damp issues and there is a pronounced smell of damp throughout the building. Picture 7 below shows the corner of the basement under street level. A moisture detector was used in this area and the readings were over 100% showing significant damp/moisture ingress in this area.

- The cracking in picture 6 is common in a property of this type and age and is of no structural concern at this stage.

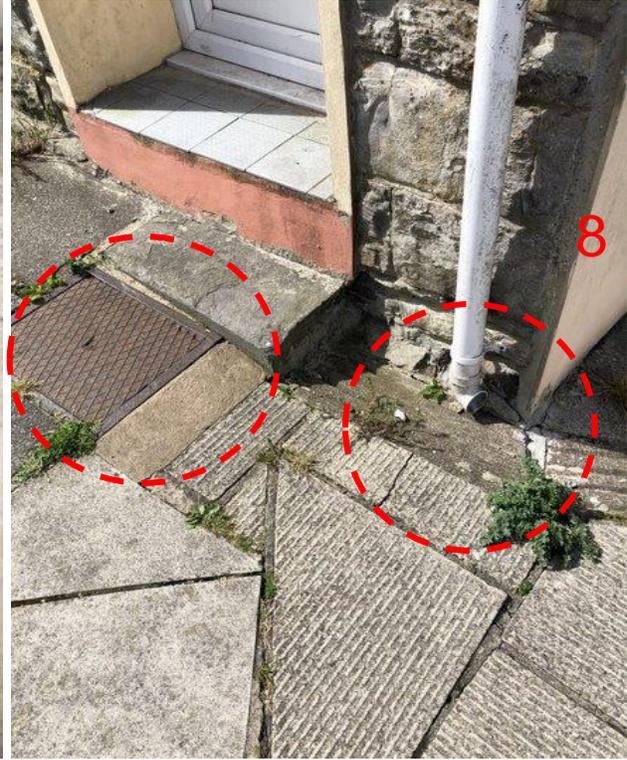
- Picture 8 shows a manhole cover to a drain system and the downpipe that spills onto the street is directly above the damp area in picture 7.

spilling onto the street is probably aspirating the damp issue. The down pipe requires a means of drainage that stops the water possibly entering the property at street level.
