Project Reference: 202137

**Report on the structural integrity of
6 Cross Morlais Street, Merthyr Tydfil, CF48 3AS**

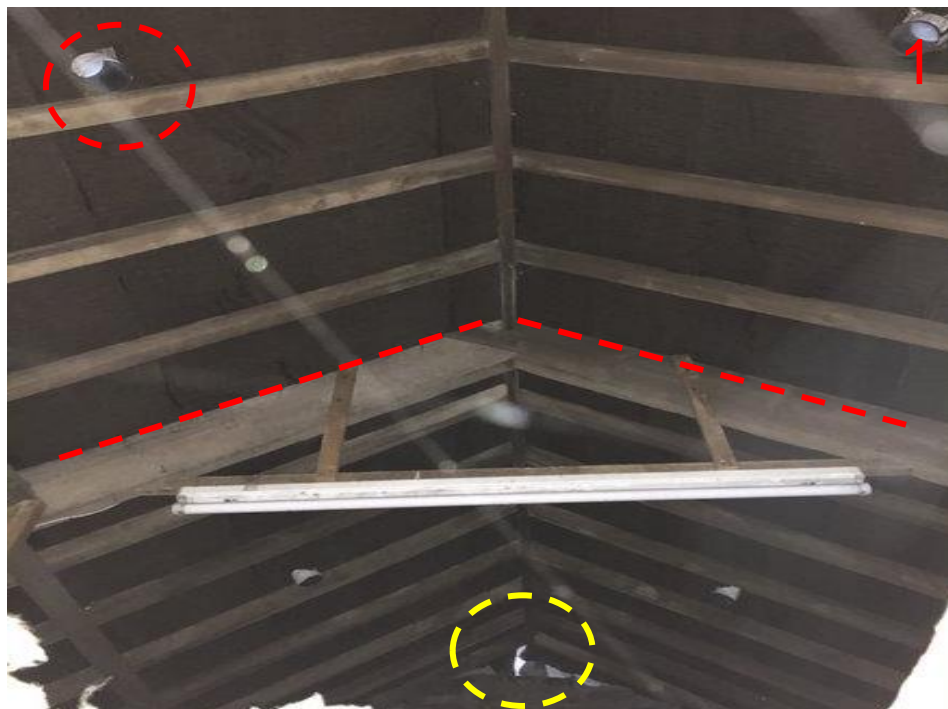
- The roof is constructed with 1 No primary 'A' frame rafter measuring 215x75 running front-to-back midspan the building, with a lowered collar running at ceiling level. There is 1 set of purlins running left-to-right on both the front and rear roof elevations. These purlins measure 120x75. See picture 1 below.
- There are roof vents on both roof sides circled in picture 1.

- The ridge board measures 150mm x 18mm.
- Roofing felt is present beneath the timber roof batten, the lining is in good order with no visible rips or tares, however daylight can be seen at the join with the neighbouring property as indicated by the yellow circle in picture 1. In this area the chimney stack has been removed and the roof lining replaced with similar tiles and 2No chimney flues.

- The uppermost structure on the original building is structurally sound, however it is advisable that an inspection of the roof is undertaken to check the daylight that is noticeable in picture 1.

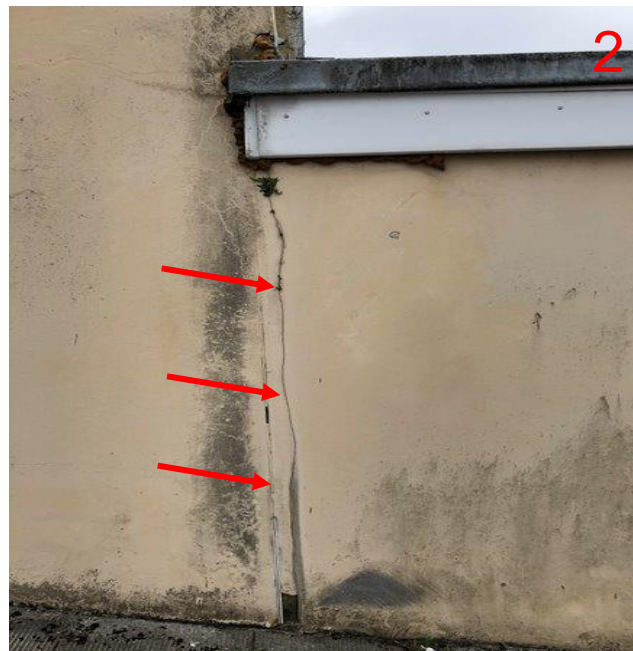
- External walls to the original building are 500mm thick random stone walls with brick inlay on the outer skin around masonry openings. The rear flat roof extension is constructed with a block cavity wall. It is unclear if there is cavity wall insulation.
- The outside and inside have been finished in cement render.
- The internal walls are mostly constructed from modern timber-frame with 12.5mm plasterboard finish which indicates there has been some form of alterations/replacement of the layout of the original internal structure.
- There is a 3-5mm vertical crack at the junction of the original building and the flat roof rear extension, see picture 2 below.

- The vertical crack in picture 2 is highly likely due to differential settlement. Differential settlement is due to movement of the substructure caused by different foundation depths and loadings. This creates a difference in the rate of structural movement or settlement, producing stresses that lead to cracks. Differential movement is commonly found where new extensions with deeper foundations abut an old house, or when bay windows and porches were built with shallower footings than the main property. It must also be noted that due to the topography of the site, the extension has probably been built on some form of made ground.

Repair- the crack is to be cleaned out and fill the crack with a non-shrink thixotropic epoxy resin based external filler to stop and further water ingress. Then observe if the crack reappears over time (3 years).

If it reappears then the crack is progressive and masonry stitching is recommended. A method of stitching would be to use helical stainless-steel reinforcement tie (i.e. Helifix™) resin bonded into the cracks of the inner and outer skin and repointed then the render made good, and/or, a reinforcing mesh system secured to the wall and rendered over to make good. The helical system is inserted horizontally every 400mm due to the nature of the cracking and have 600mm bonded length either side of the crack bending it around any corners where necessary. This is to cease any further movement of the superstructure and stitch the masonry.

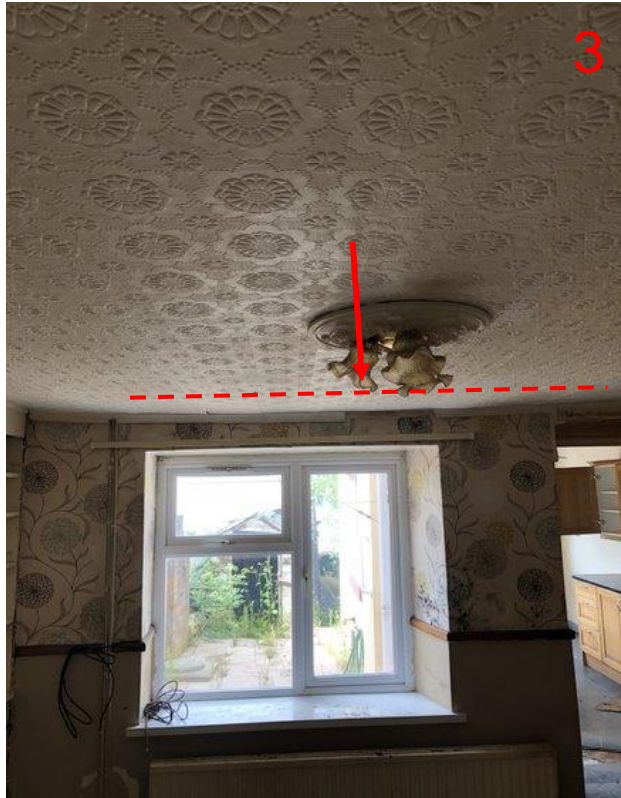
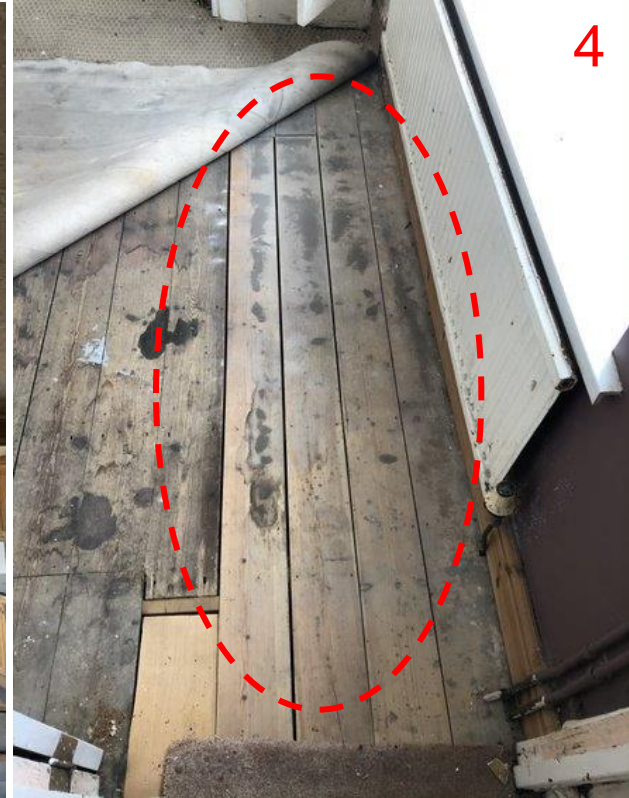
- There are various undulations in the floor throughout the building, including the stairs and landings.
- The floor joist run front-to-back and the ceiling in the rear room of the basement appears to show deflection of the floor joists. However, when the carpet was removed, it was found that the floor joists and floorboards had been replaced in the area over the rear window indicated in picture 3&4.

- The floor joist repair in picture 3&4 appears to have been carried out correctly, however the reason why the ceiling is still bowing is due to either the repair not continuing in the old floor joist pocket, or the ceilings have dropped. It is recommended that the floorboards be removed to fully inspect the repair.

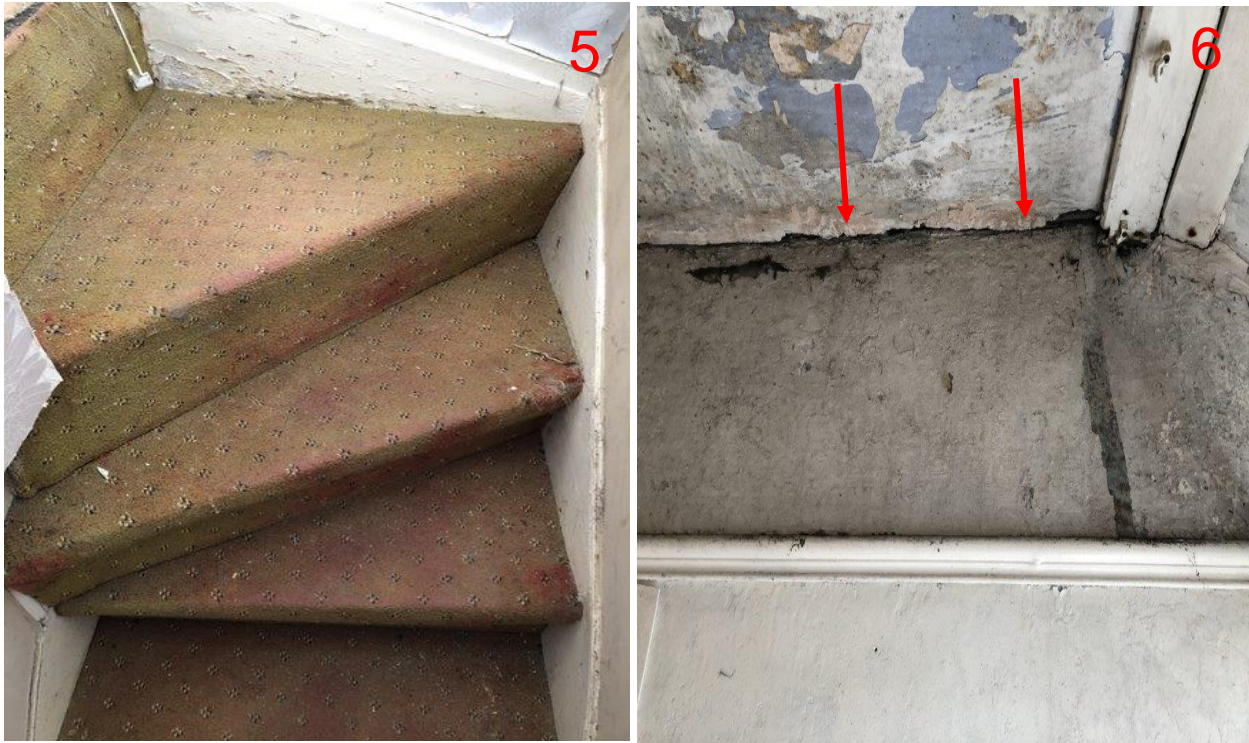
- Both sets of stairs do not conform to modern day building regulations (picture 5), however because the stairs are in situ, they therefore do not need to conform to building regulations. Nevertheless, this is detailed as a Health and Safety issue.

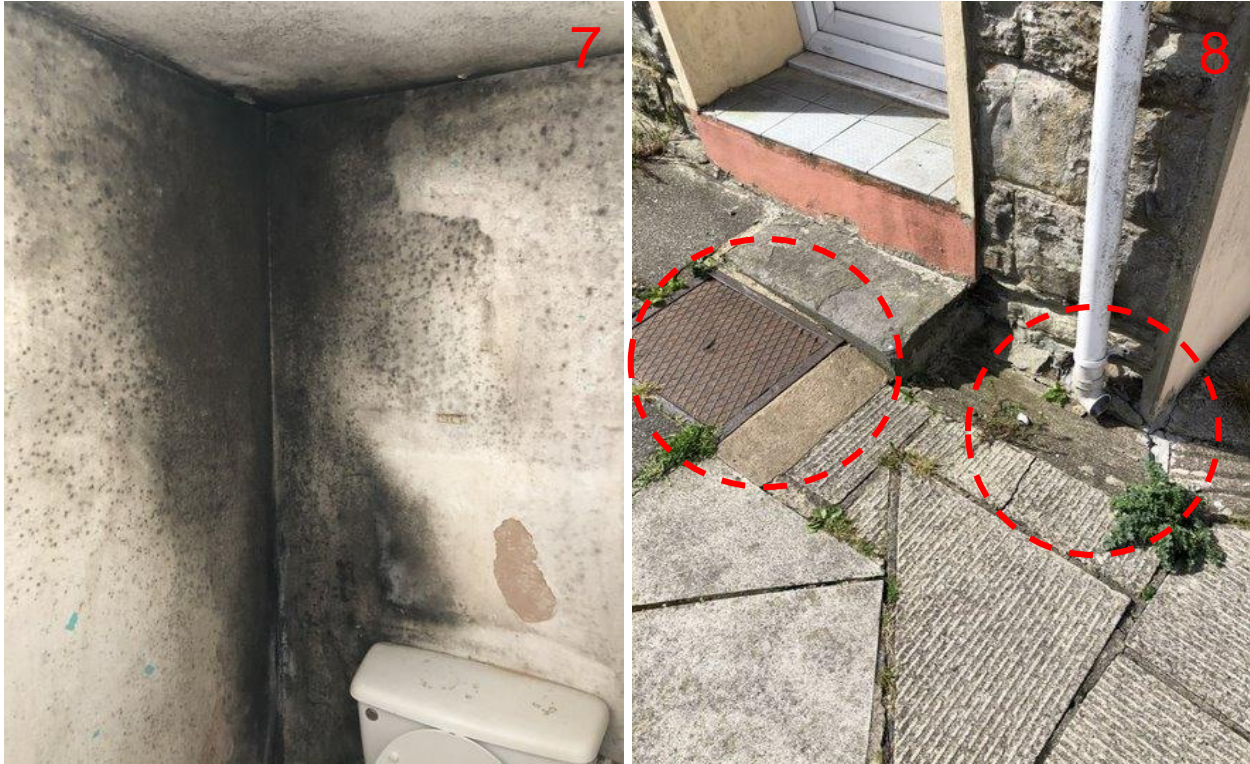
- The basement is suffering from damp issues and there is a pronounced smell of damp throughout the building. Picture 7 below shows the corner of the basement under street level. A moisture detector was used in this area and the readings were over 100% showing significant damp/moisture ingress in this area.

- The damp spores in picture 7 are in the same area as the issues raised in picture 8, therefore it can be assumed that they are linked. A drain inspection is recommended at the LH front corner of the property and the downpipe that is spilling onto the street is probably aspirating the damp issue. The down pipe requires a means of drainage that stops the water possibly entering the property at street level.
